A. The wreck

Field drawing

## Reconstruction drawings

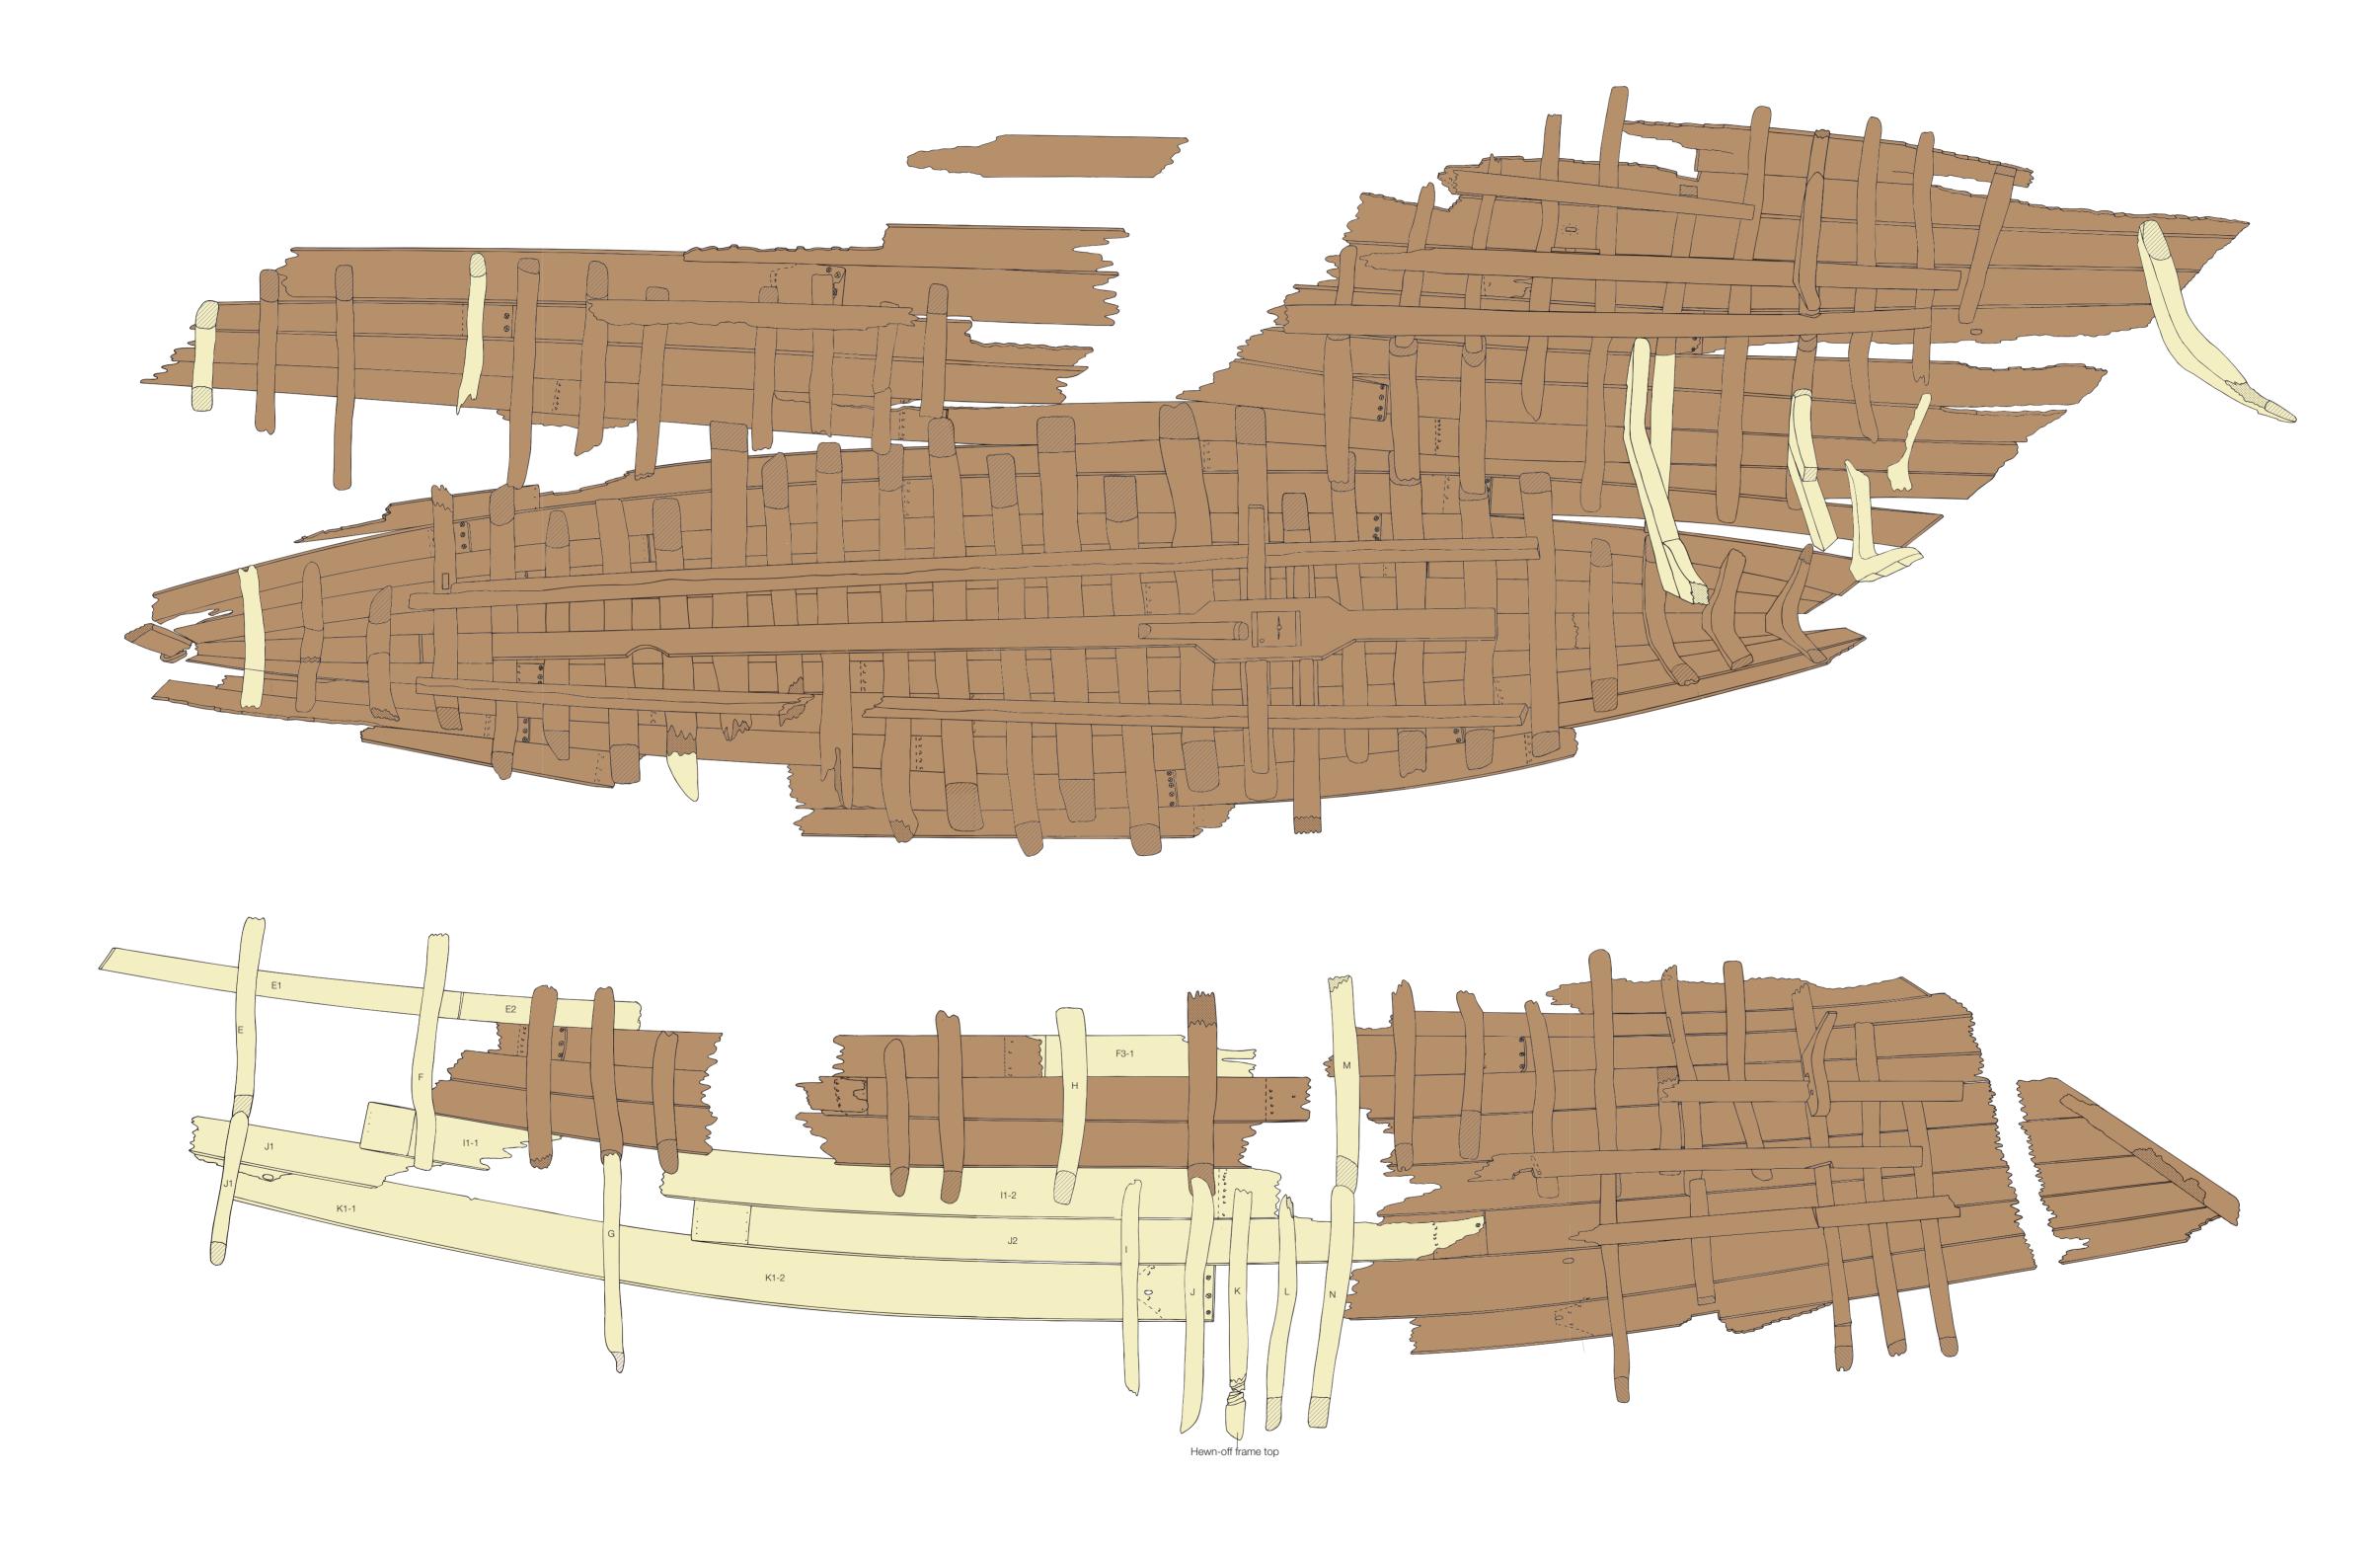
B. The wreck

Still joined-up timbers

Detached timbers returned to their original positions

B. The wreck in situ after the detached timbers have been lifted and in part returned to their original positions, with the starboard side reconstructed as much as possible beside the bottom.

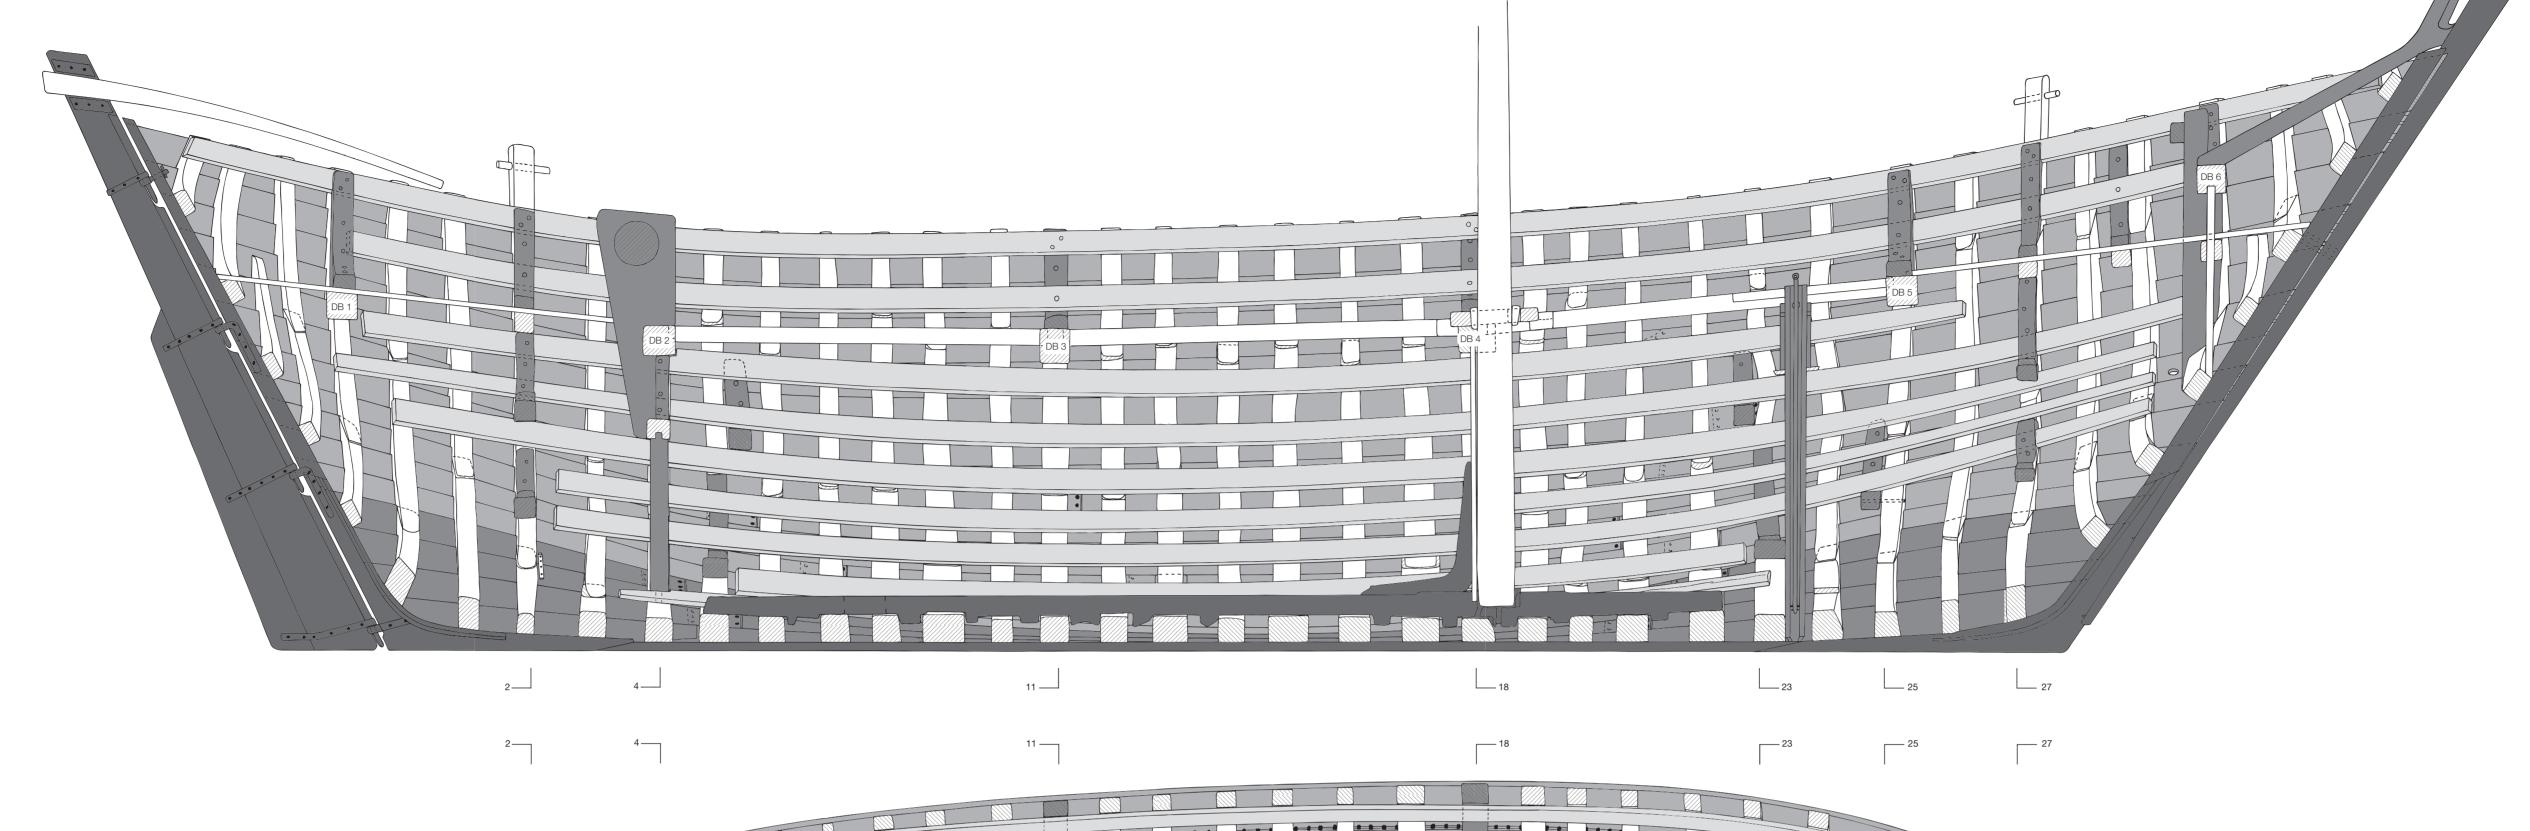
## A. Interior of the port shell

## Legend to A

- Keel plank, stern- and stem hooks, stern- and stemposts,
- false stem, keelson, mast partner Bottom planks, windlass, anchor bitt, transverse construction/ cross-/connecting beams with (deck) knees, pump barrel, drain, forked support
- Planking of the sides
- Ceiling boards
- Frames, crossbeams, stringers, deck planks, mast, bitts, tiller
- Cross-cut wood
- DB 2 Crossbeam number

- A. Interior of the port side shell.
- B. Top view of the deck plan (port) and the frame plan (starboard).
- Bottom planking, keelson, (deck) knees, topside crossbeam, pump barrel, drain, windlass, anchor bitt, forked support
- Planking of the sides

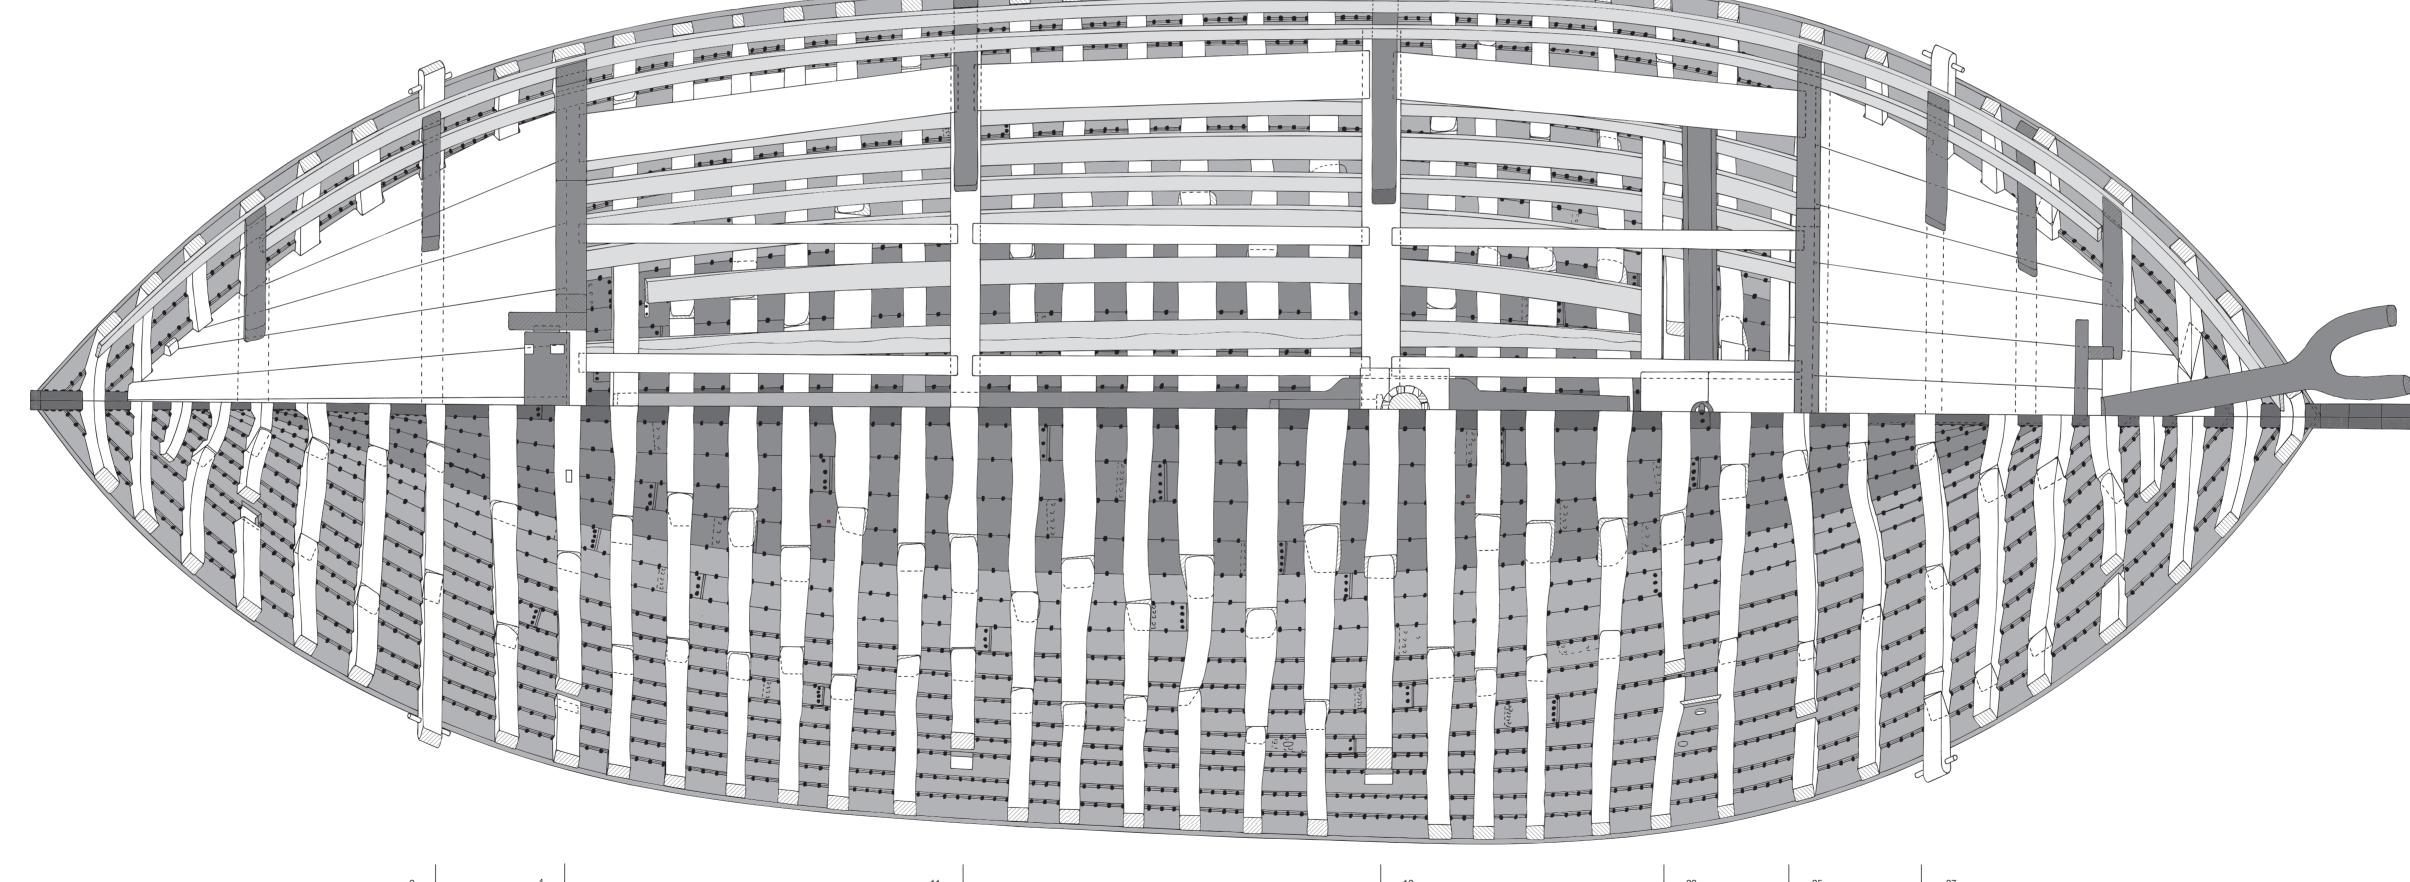
B. Top view

- Legend to B
- Keel plank, stern- and stem hooks, stern- and stemposts,

- Ceiling boards
- Frames, deck planks, gangway planks, stringers
- Cross-cut wood
- Sintel nails on the inside of the carvel seams
- 6 Frame number 6 — Frame number

- Clamped moss caulking on the inside of the clinker seams
