A. The Rutten cog in situ, with detached timbers (yellow), ceiling boards (pale ochre), frames (white), planking of the sides (dark ochre), bottom planking (brown), keel plank and stern- and stem hooks (red-brown), ballast of flint (blue) and brick (red), and the distribution of the finds.

- A. The wreck *in situ*, with detached timbers, ballast, and distribution of finds.
- B. The wreck after removal of the detached timbers and the ballast, and the repositioning of the frame and ceiling parts, keelson and riders ripped out by a bulldozer in 1980.

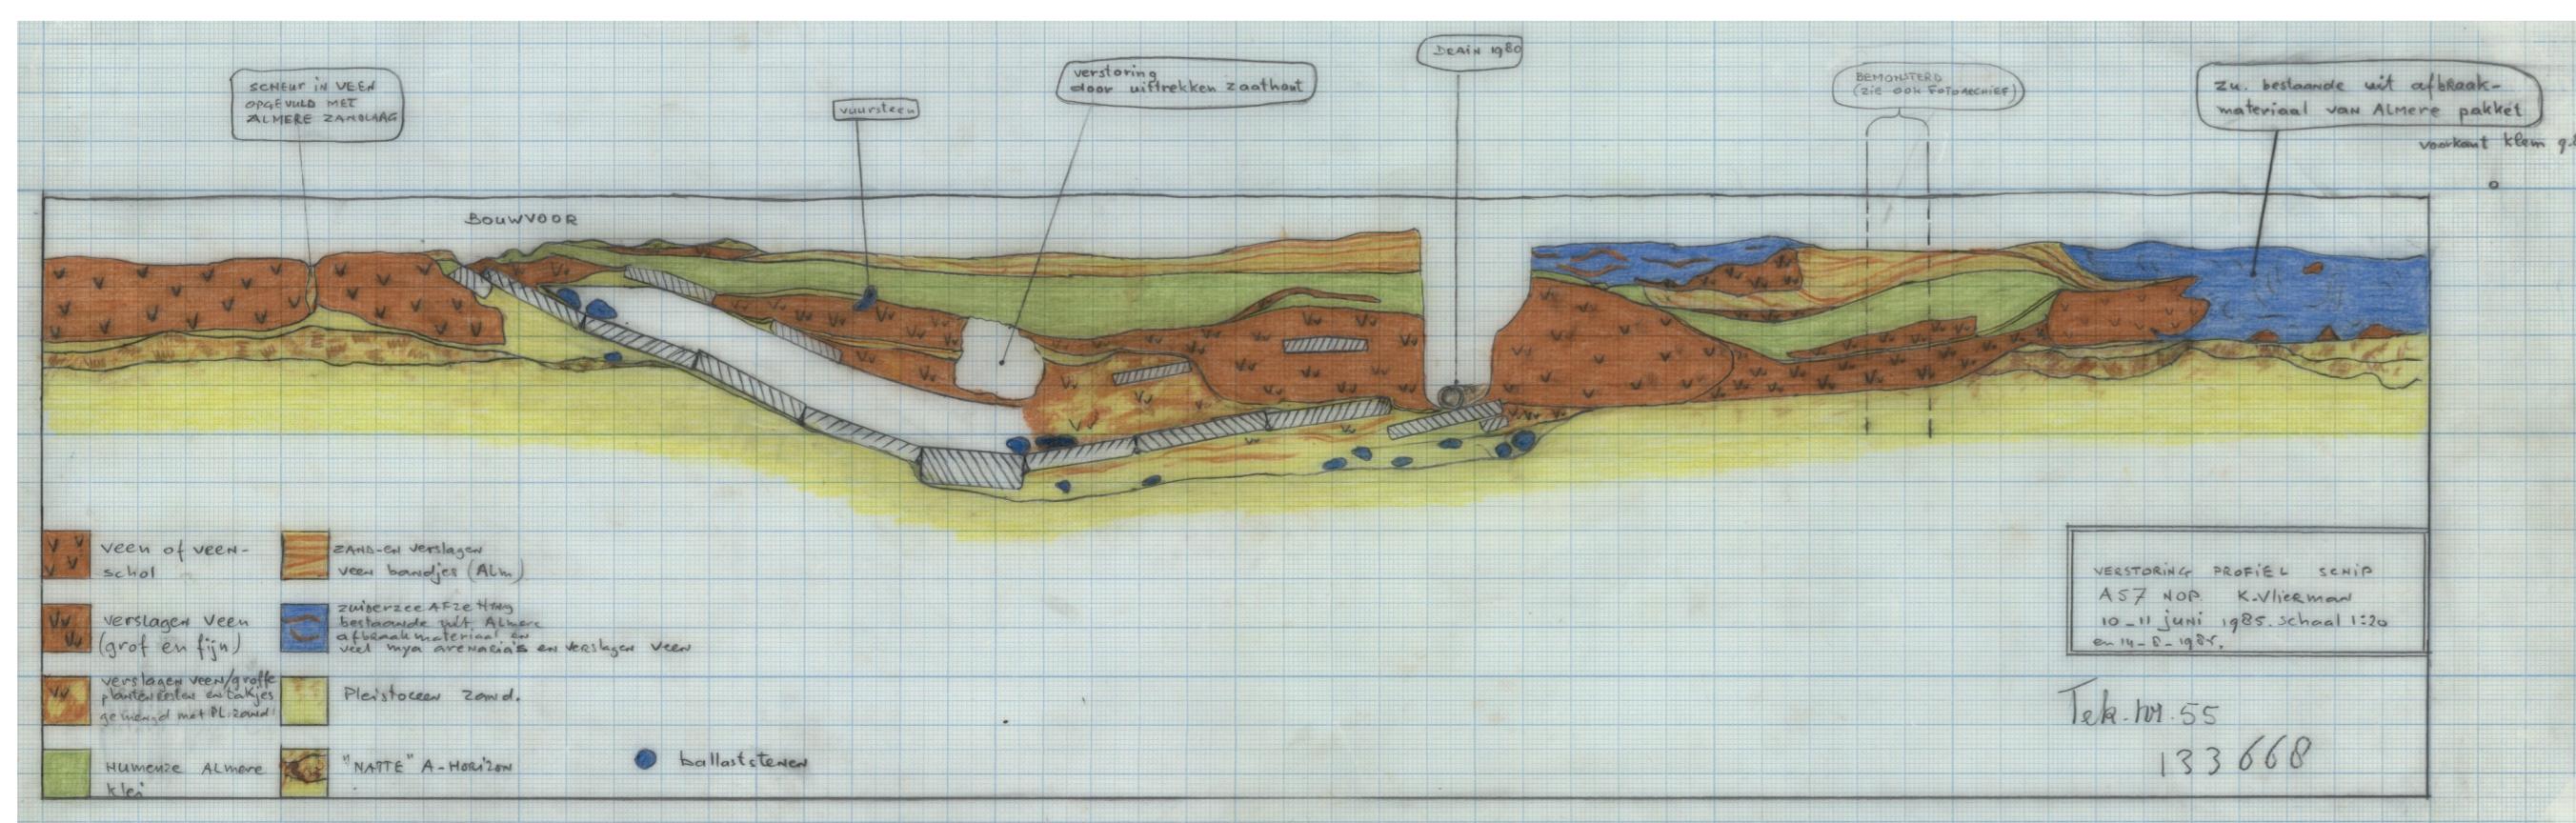
B. Section of soil profile

B. The soil profile and section of the wreck, at 7.1 m on the tape measure.

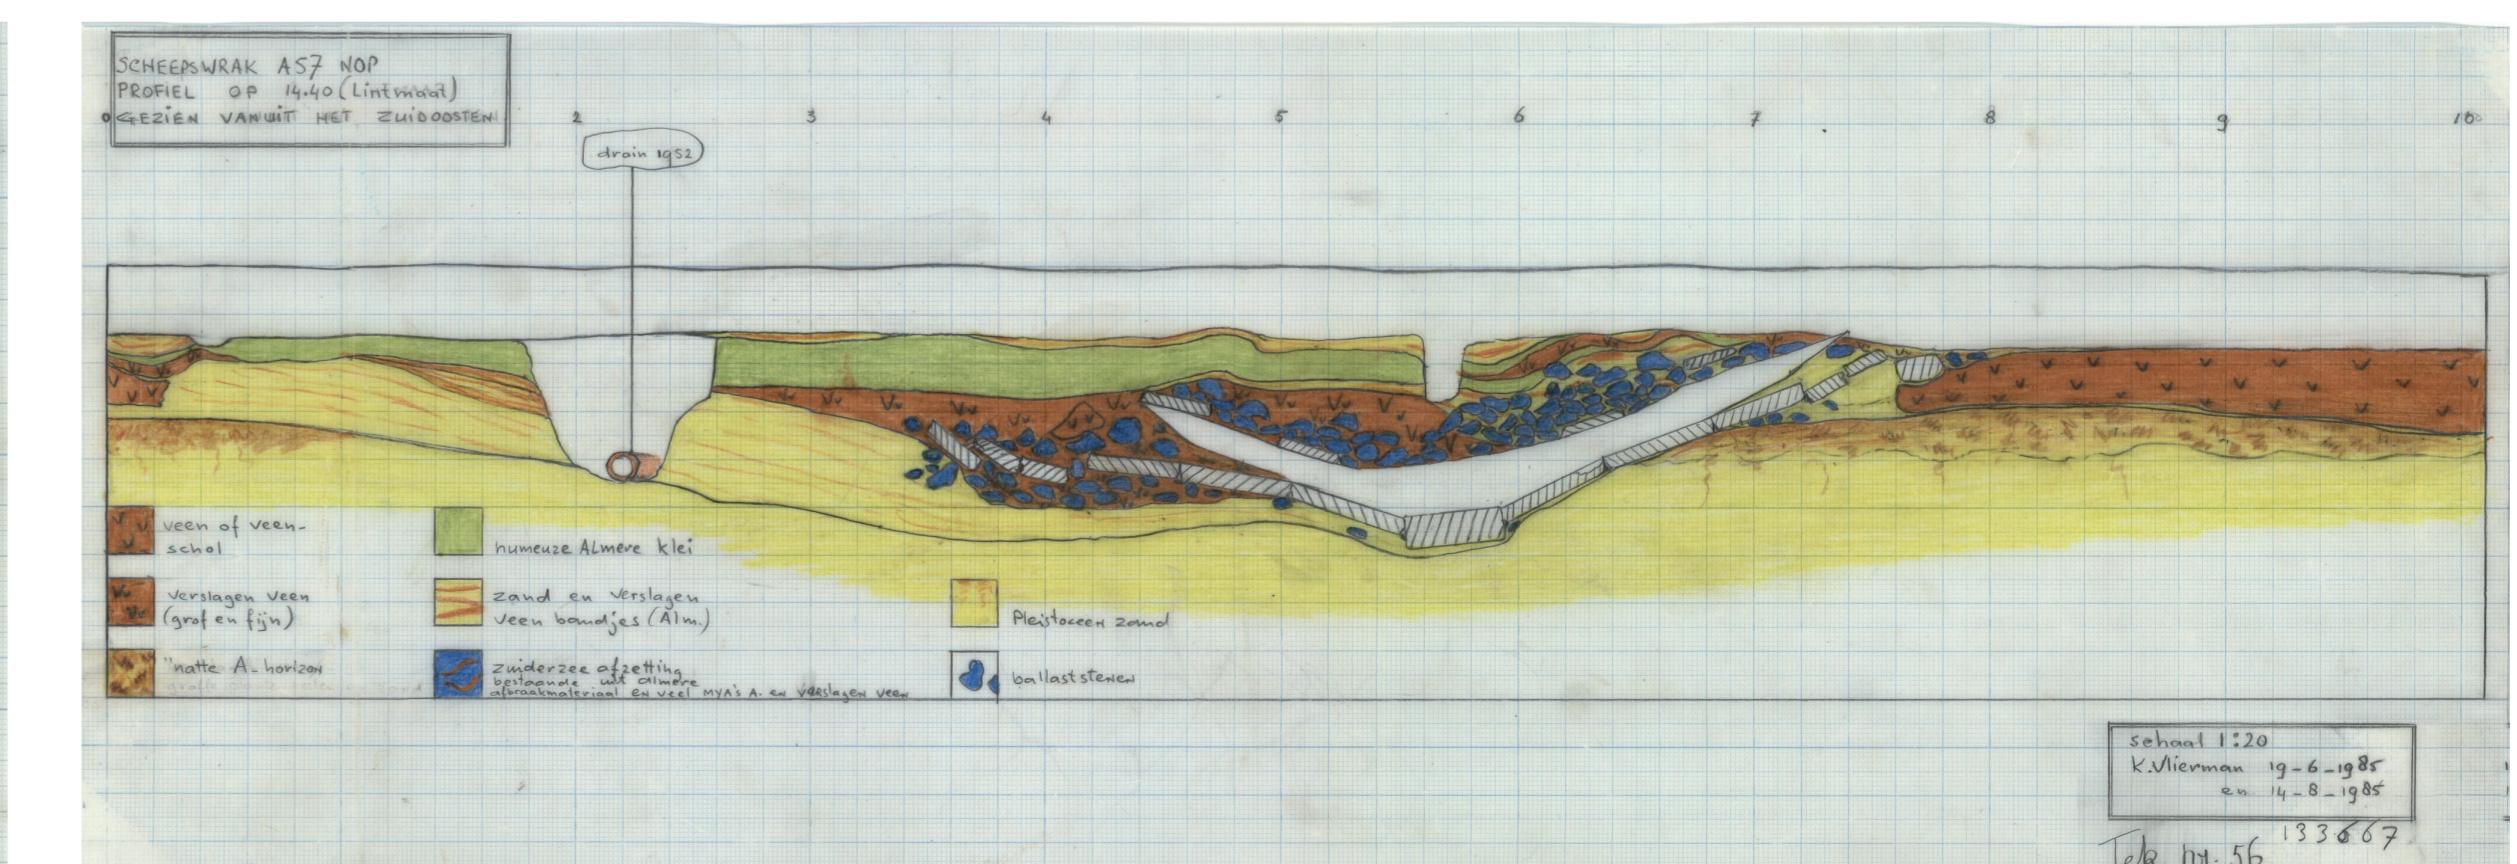
C. Section of soil profile

C. The soil profile and section of the wreck, at 14.4 m on the tape measure.

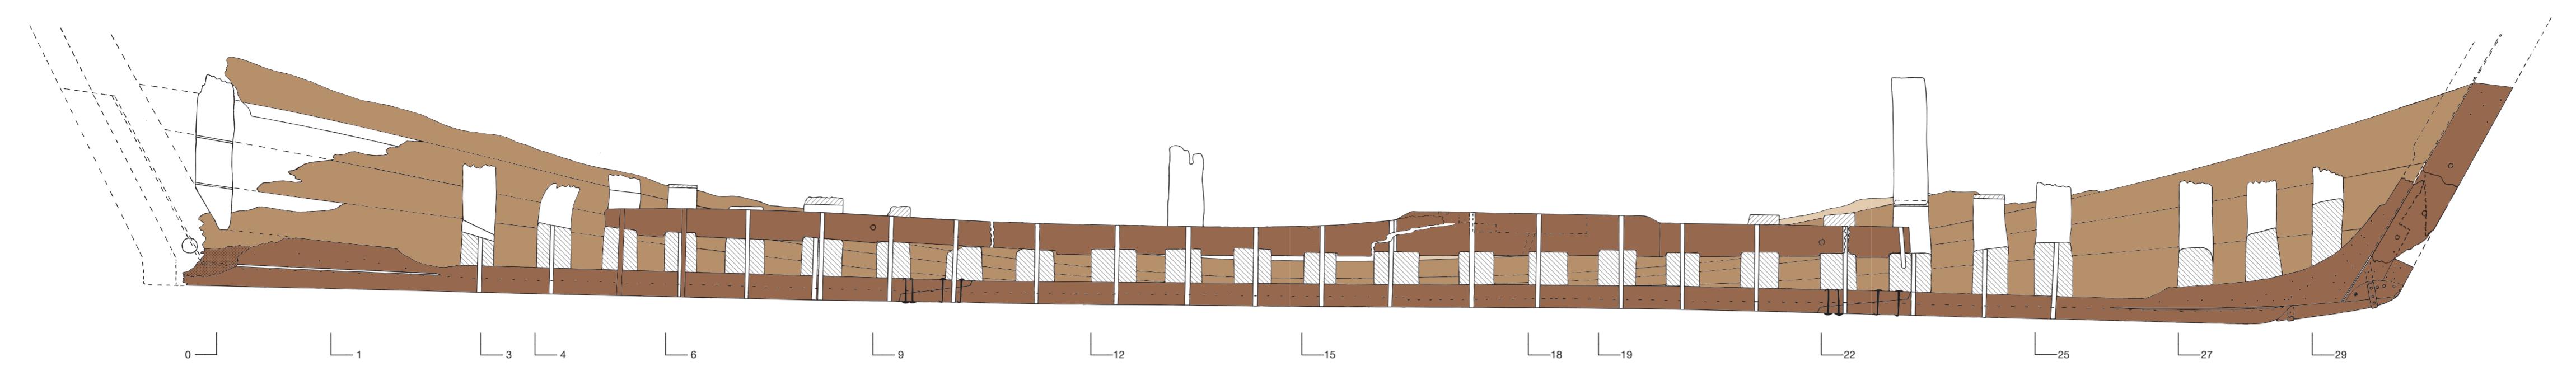
C. Longitudinal section, port side

- C. Longitudinal section, supplemented with recovered frames and planks of the port side (reconstructed).
- D. Cross-sections.

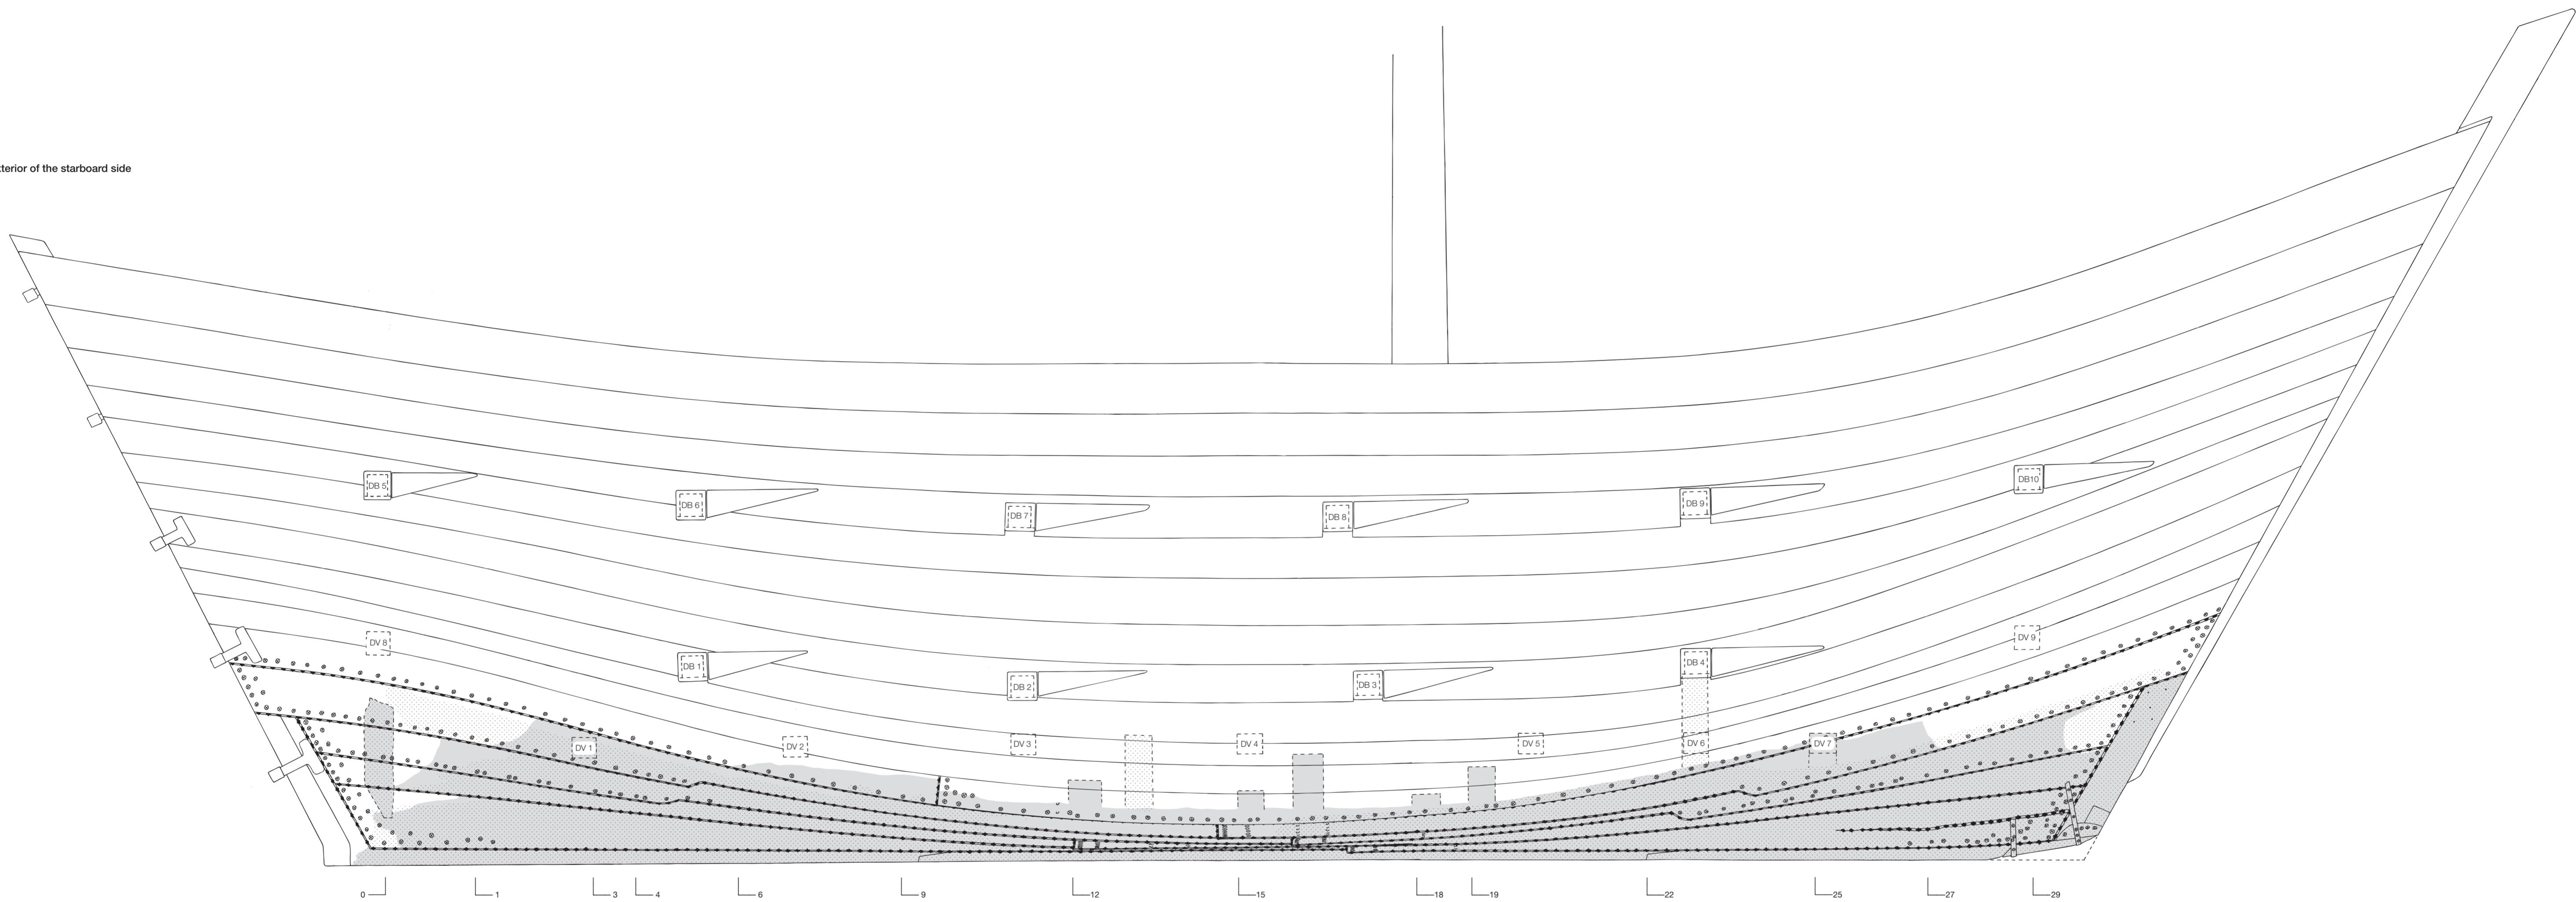
A. Exterior of the starboard side combining the recovered parts of the starboard and port sides, showing the presumed locations of protruding crossbeams (DB) and cross connections (DV), and the clamped moss caulkung.

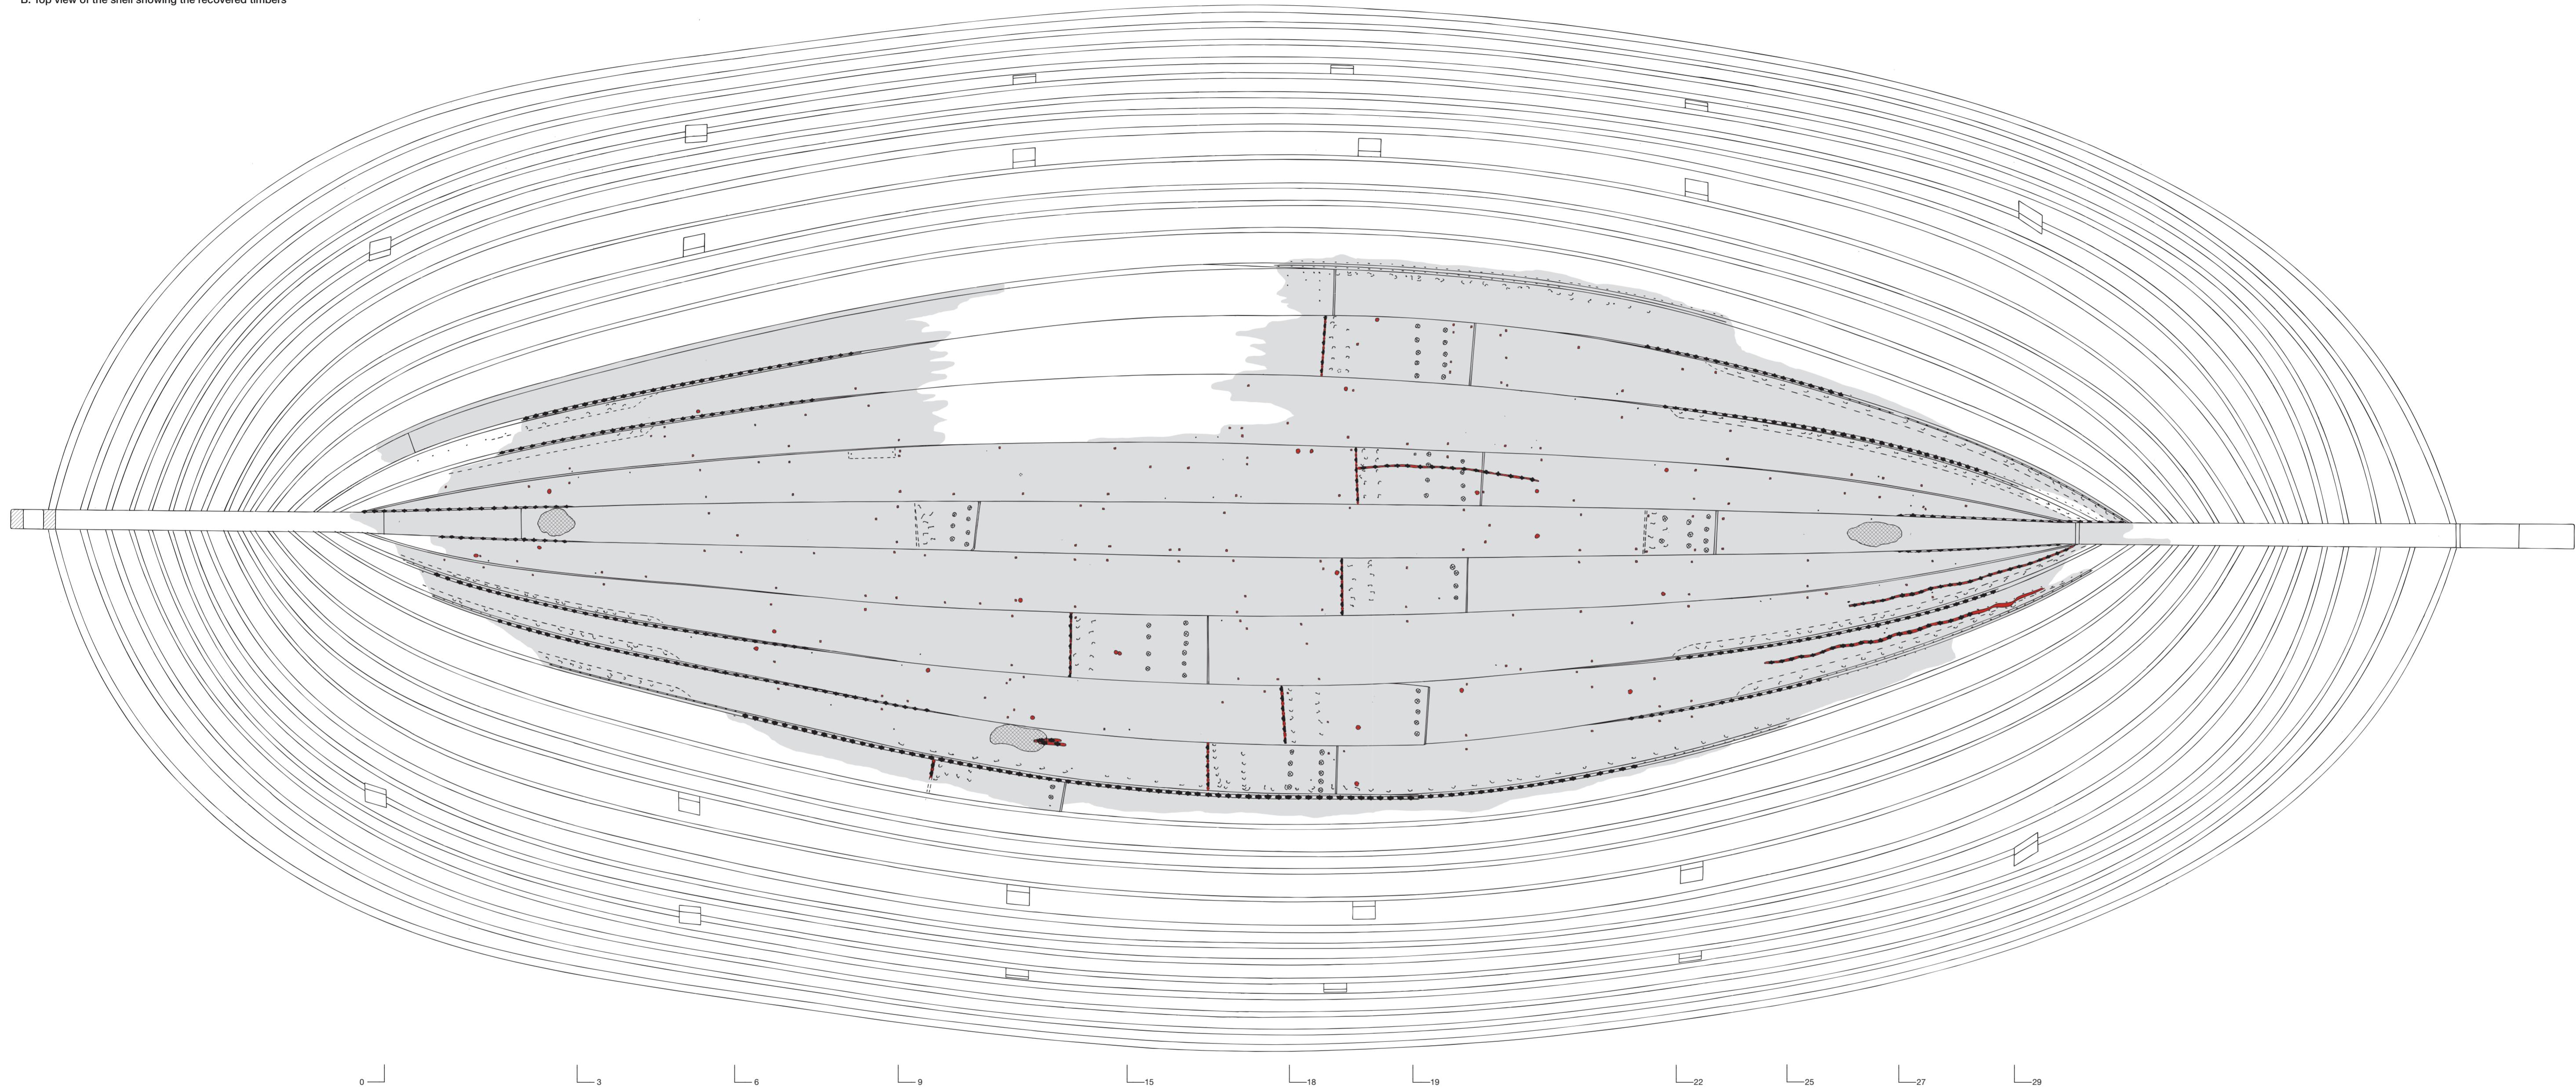
B. Top view of the shell showing the recovered timbers

B. Top view of the shell showing the recovered parts, the scarfs, the observed nail-hole plugs and treenails of temporary framing employed during construction, and clamped moss caulking.
