Reconstruction of the side

Reconstruction drawing

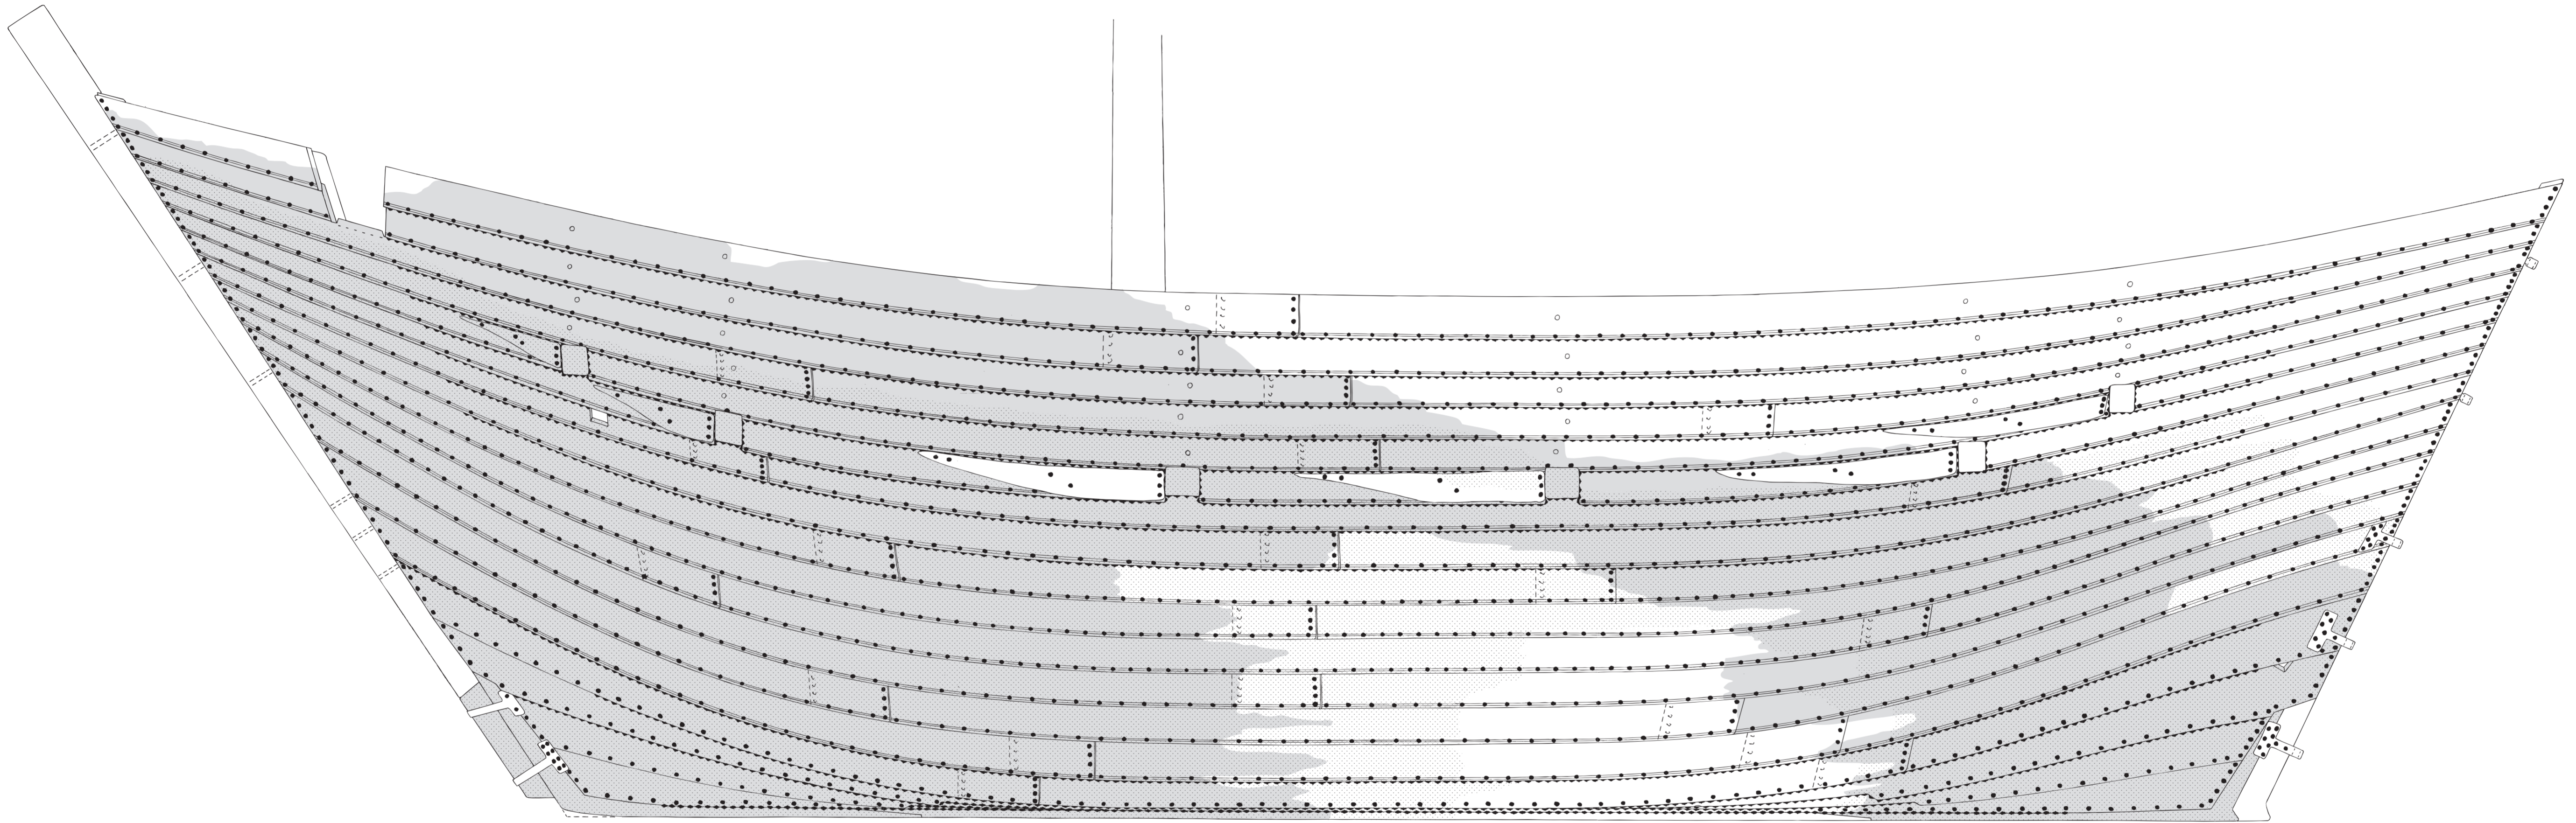
Global, provisional reconstruction of the side of the Doel-1 cog, combining the recovered parts of the shell strokes on the starboard and port sides. The clinker fastenings are nailed at regular intervals, though occasionally nails occur in pairs. The cracks in the planks closed with clamped moss caulking were not recorded during salvage and hence are not drawn.
